Flushometer Care & Service 101

Part 3: Top-mount Sensor Diaphragm Flushometers

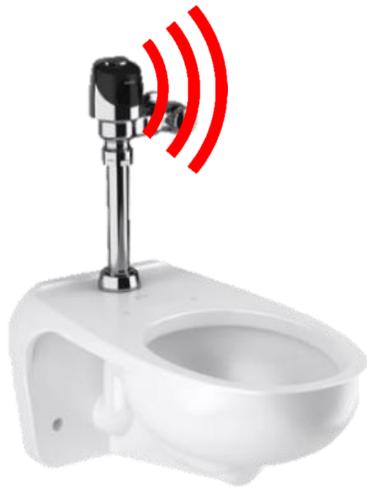
①

Activating the sensor sends a signal to the solenoid to open, creating a relief path for water from the upper chamber through the flex tube of the diaphragm and through the valve to the fixture. Water pressure below the diaphragm forces the diaphragm to lift, pushing water out of the upper chamber and through the lower chamber into the fixture.

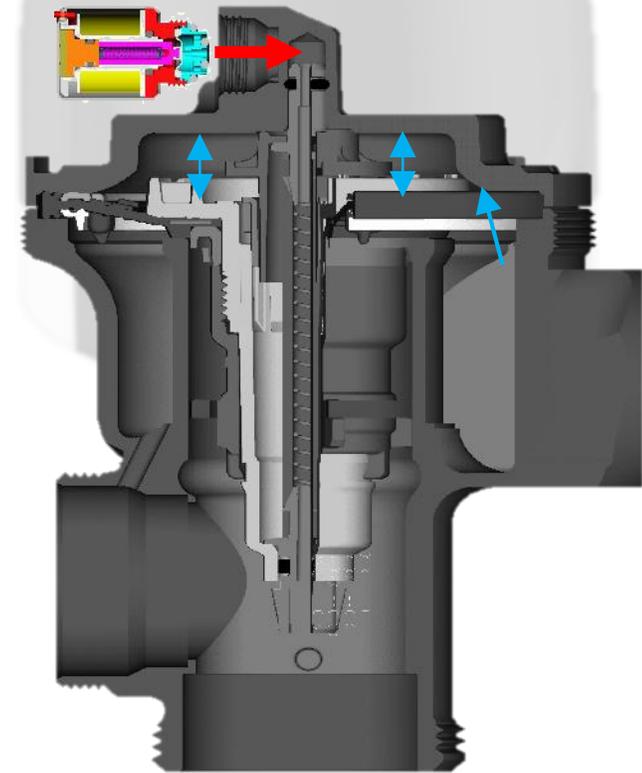
②

The sensor sends a second signal to close the solenoid, sealing off the relief path in the upper chamber. The upper chamber gradually refills through the diaphragm bypass, forcing the flex tube diaphragm assembly back down onto the seat and shutting off the flush.

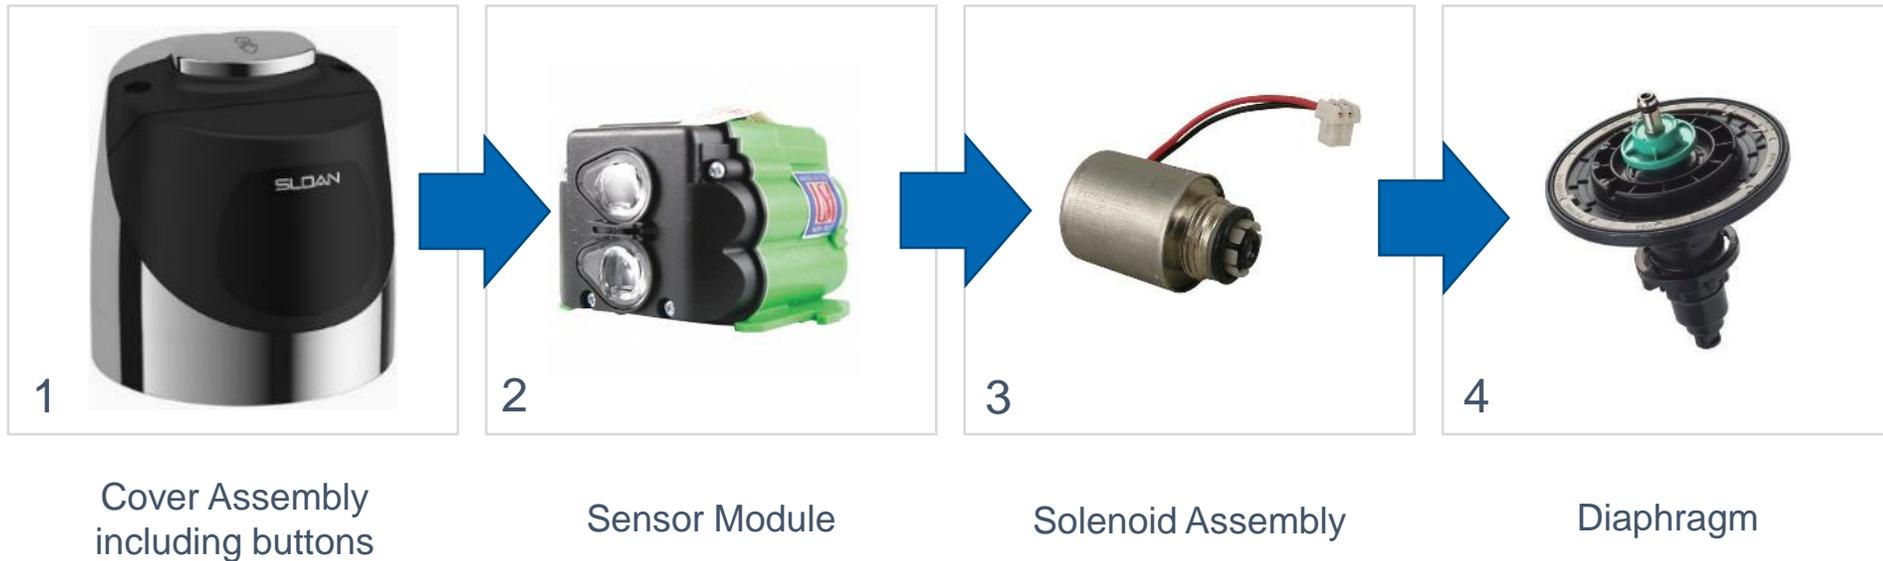
Troubleshoot in order from the top to the bottom of the valve

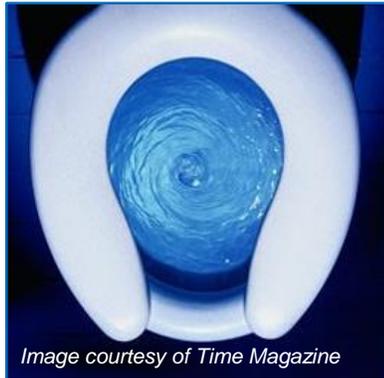
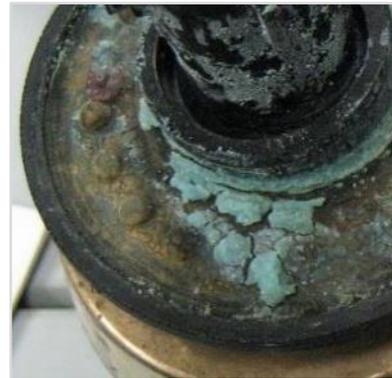
Debris blocking diaphragm bypass

Symptom	Cause	Solution
Continuous flush with no shut-off	Solenoid stuck open	Replace solenoid assembly EBV-136-A
	Debris blocking diaphragm bypass	Clean diaphragm to clear bypass orifice
	Debris under diaphragm	Remove debris
	Low pressure drop	Check facility or municipal line pressure
	Diaphragm assembly compromised O-ring, cracked plastic guide (due to age)	Replace diaphragm assembly with proper gpf kit

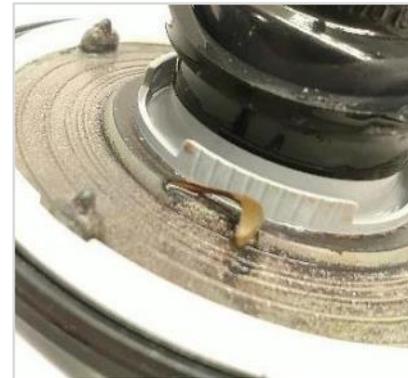
Debris under diaphragm

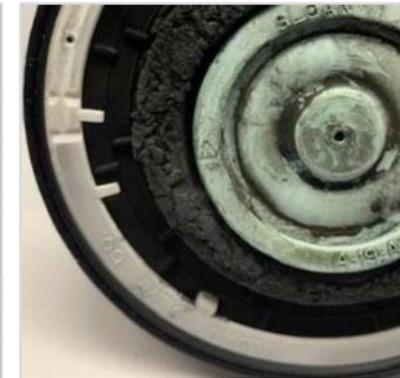
Degraded diaphragm assembly

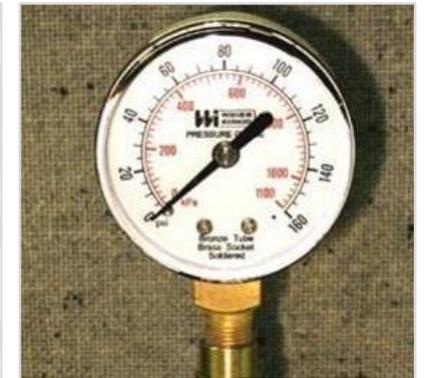
Low pressure drop

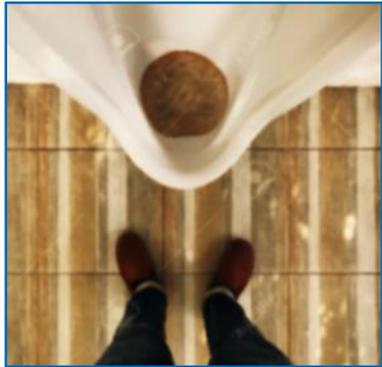
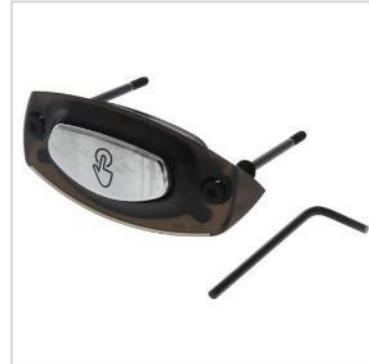
Override button damaged

Symptom	Cause	Solution
No activation when sensor is activated or override button depressed	Override button damaged	Replace override button (3 different types)
	Batteries are depleted	Replace batteries
	Sensor module compromised	Replace sensor module
	Solenoid stuck closed	Replace solenoid assembly EBV-136-A
Sensor does not activate, override button does activate	Sensor window scratched	Replace sensor window
	Sensing malfunction	Replace sensor module

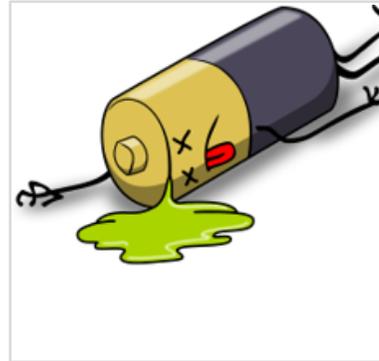
Batteries depleted

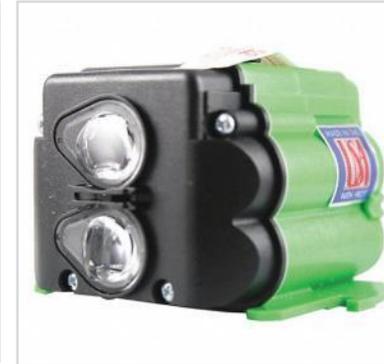
Sensor module compromised

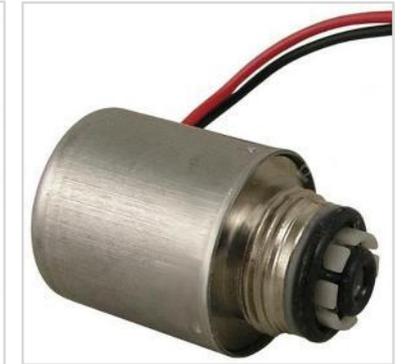
Solenoid stuck

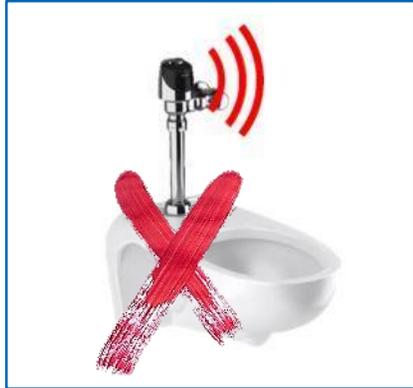
Rough-in too low

Symptom	Cause	Solution
Sensor does not activate, override button activates	Rough in too low, sensor is detecting front of toilet	Raise the supply or "elbow up" the stop Reduce sensor range (older units that cannot self-adapt only)
	Sensor not centered properly	Re-orient sensor until pointed straight forward
	Reflection issue	Reduce sensor range (older units that cannot self-adapt only)
	Rubber strip (wiper) missing from inside the cover	Contact Sloan Technical Support

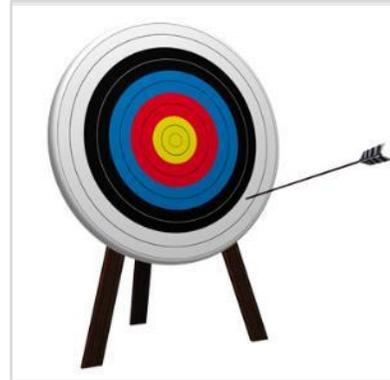
Sensor not centered

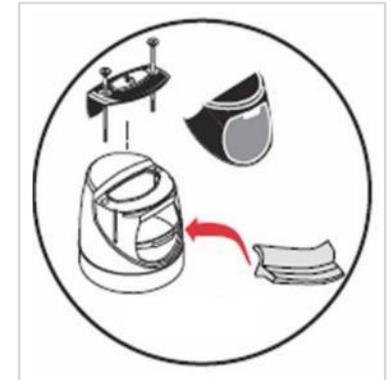
Missing "wiper"

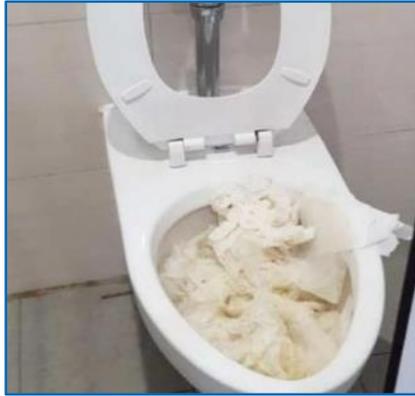
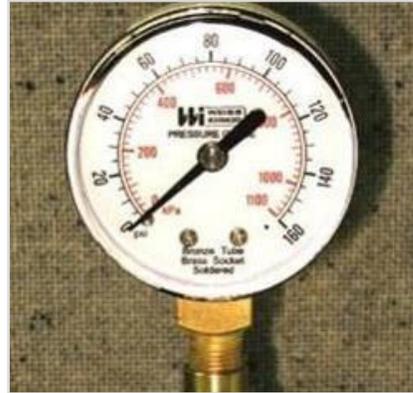
Low pressure

Symptom	Cause	Solution
No evacuation when flushed (either sensor or override button)	Low pressure (<25 psi / <1.7 bar)	Address plumbing system deficiencies
	Low consumption (LC) or urinal diaphragm installed in older closet	Install correct gpf diaphragm
	Short flushing (perforated diaphragm)	Replace diaphragm
	Locking ring not properly tightened (DFB - dual filter bypass diaphragm)	Tighten locking ring

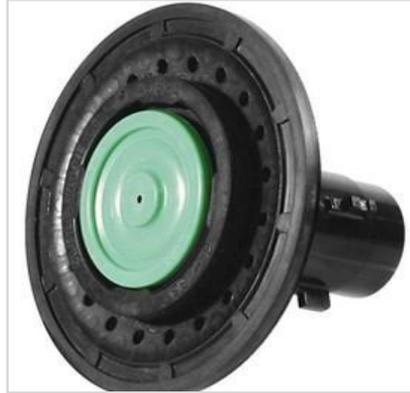
Improper, low consumption, or urinal diaphragm

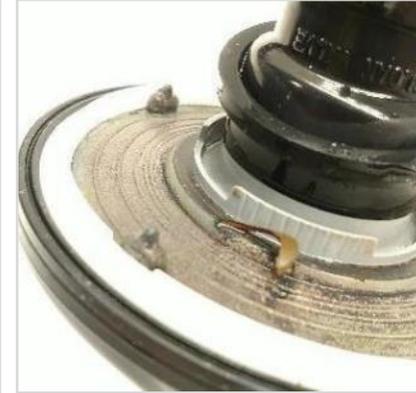
Perforated diaphragm

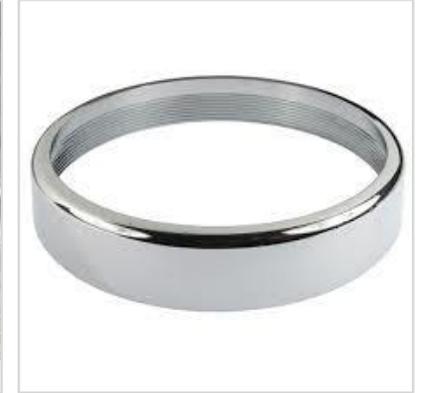
Locking ring not properly tightened

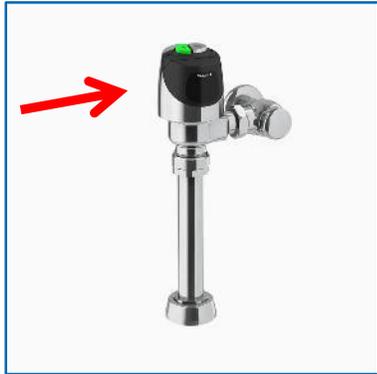
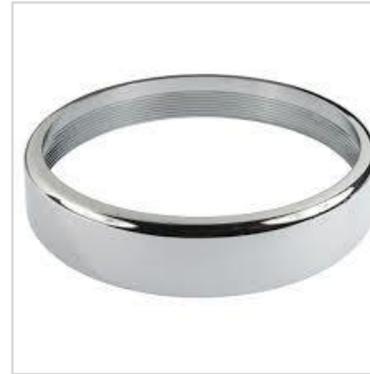
Locking ring not properly tightened

Symptom	Cause	Solution
Water leaking from threads above or below the locking ring	Locking ring not properly tightened	Turn of water supply at stop, loosen and then re-tighten locking ring
	Diaphragm Assembly compromised	Replace diaphragm assembly
Water leaking from threads above the locking ring	Solenoid leaking	Turn of water supply at stop, hand tighten solenoid or replace solenoid

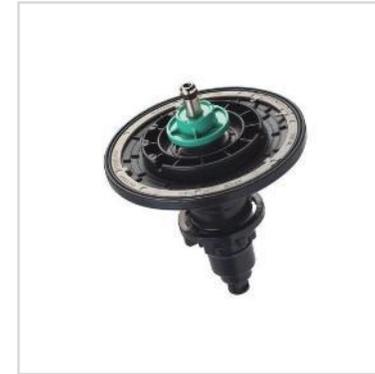
Diaphragm assembly compromised

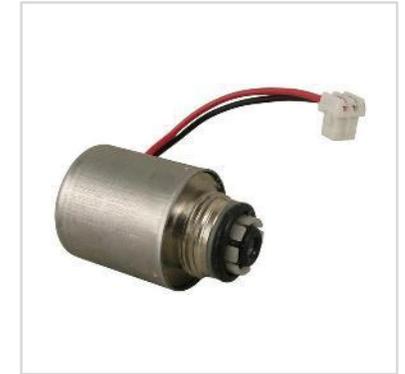
Solenoid leaking

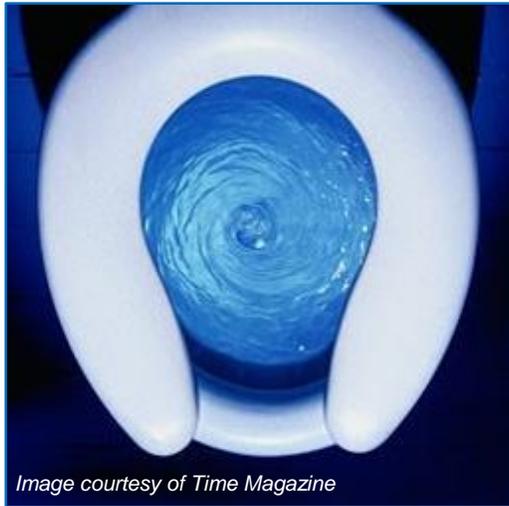
Symptom	Cause	Solution
Flush duration is randomly normal, long, or short	Pressure fluctuation within the facility	Check plumbing system pressure and flow capacity

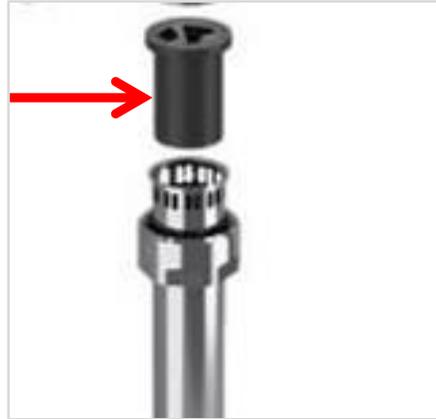
Worn vacuum breaker sack

Symptom	Cause	Solution
Dripping from above the vacuum breaker coupling during or after flush	Vacuum breaker sack damaged by over-tightening the vacuum breaker coupling	Clean vacuum breaker tube and replace vacuum breaker sack with V551A or V651A high backpressure VB repair kit
Dripping from below the vacuum breaker coupling during or after flush	Worn or degraded vacuum breaker sack

Wet the gasket prior to installation and hand tighten then “snug” with wrench

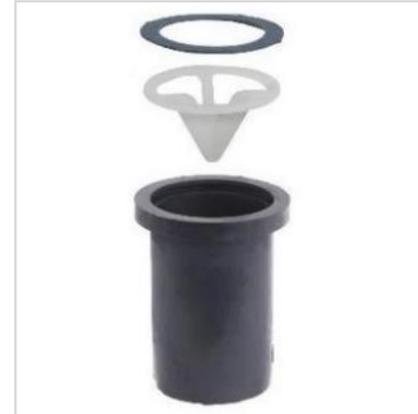
Sloan V651A repair kit

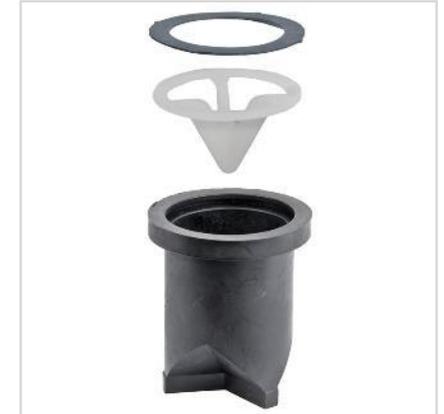
Sloan V551A repair kit

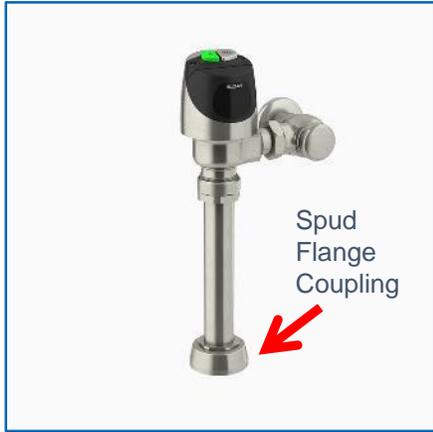
Sloan F3 friction ring

Symptom	Cause	Solution
Leaking from spud flange coupling	The spud flange coupling has loosened	Tighten spud flange coupling
	Spud flange coupling gaskets have become worn	Replace F3 friction ring and VBF5 gasket (1-1/4" or 1-1/2") or F5 gasket (3/4" or 1")

Clean the threads prior to installation, and never use pipe dope or grease!

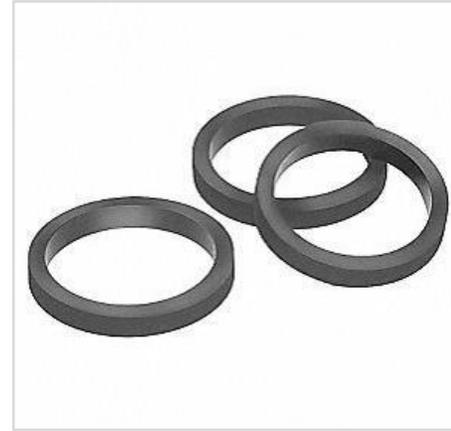
Sloan VBF5 gasket

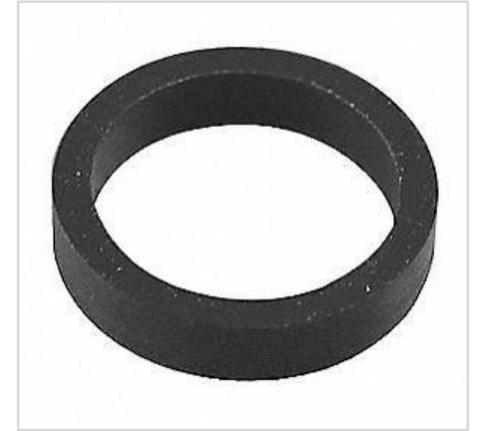
Sloan F5 gasket

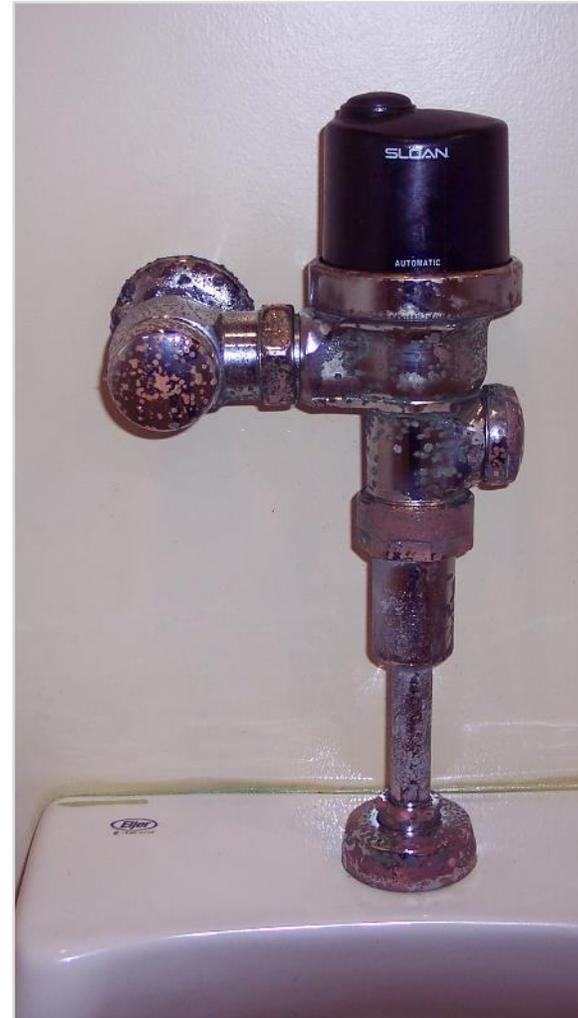
Clean with soap and water

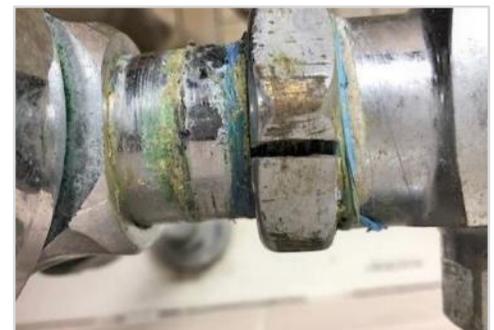
“Snug” – don’t over tighten

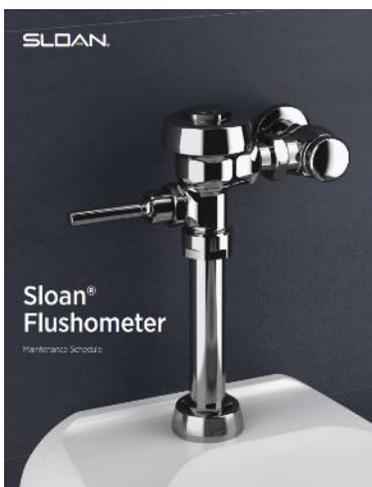
[Sloan Flushometer Maintenance Schedule Brochure](#)

Life Expectancy Industry Standard / Sloan Standard	3/4+ years	3/6+* years	5/7+ years	20/25+ years
