# Flushometer Care & Service 101

## Part 5: ESS Exposed Sensor Flushometers

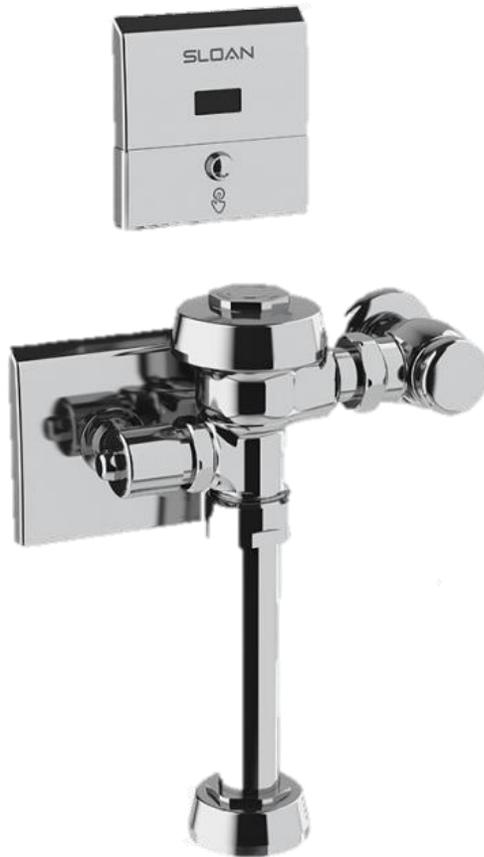
# EL-1500 and EL-1500L Series Sensor

ESS
LED Color	Red
Start-up Time	1 minute
Start-up Indicator	Solid Red LED during start up
User is Detected	Slow flashing red LED, then rapid flashing red LED when unit is armed (ready to flush – 16s for closet and 8s for a urinal)
Flush Delay	Closet – 3s / Urinal – 1s
Low Battery Indicator	NA (Hardwired 24 Volt)
Link to Installation Instructions	<a href="#">ROYAL ESS</a>

Indicator	Issue	Resolution
Continuous slow flashing red LED	Improper start-up	Disconnect power for 60 seconds and repeat installation procedure
Continuous fast flashing red LED	Sensor is detecting a target	Remove obstruction or clean sensor window
Red LED flashes an “SOS” pattern (three short, three long, three short)	Wiring connections are incorrect or there is an electrical short	Re-wire the sensor correctly and repeat installation procedure
LED lights do not function	No power to unit	Check power supply and repeat installation procedure

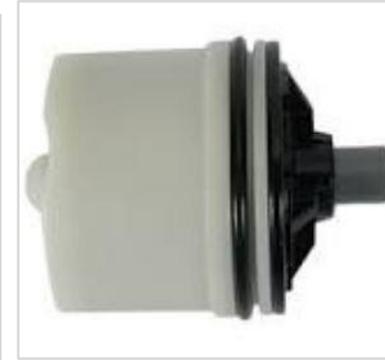
Solenoid

Symptom	Cause	Solution
Sensor LED blinks but does not flush, Override Button works	Sensor not calibrated	Power off for 60 seconds, power on again for sensor to auto adjust for 60 seconds, do not block sensor
Sensor LED does not blink or activate flush, Override Button works	Sensor damaged	Replace EL-1500 Sensor Assembly
	Sensor wired incorrectly	Rewire Sensor Assembly properly
Sensor LED blinks, but does not activate flush, solenoid makes buzzing noise, Override Button works (or buzzes with no flush)	High static pressure above 80 psi (552 kPA)	Reduce Static Pressure
	Undersized wiring, insufficient voltage	Reinstall with 18 gauge wiring (minimum), replace transformer
Sensor and Override Button work, Solenoid buzzes (or may trickle water to bowl) but does not activate flush	Solenoid corroded, oxidized or stuck	Replace EL-124-2 Solenoid or rebuild with EL-163-A Solenoid Shaft Assembly Repair Kit
	Damaged Solenoid Shaft Assembly	Replace with EL-163-A Solenoid Shaft Repair Kit

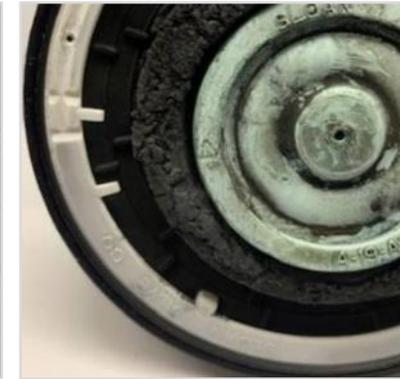
Debris under diaphragm

Symptom	Cause	Solution
Continuous flush with no shut-off	Debris blocking diaphragm bypass	Clean or replace diaphragm (replace inner cover too)
	Debris under diaphragm	Remove debris
	Low pressure drop	Check facility or municipal line pressure
	Diaphragm assembly compromised, cracked plastic guide (due to age)	Replace diaphragm assembly with proper gpf kit

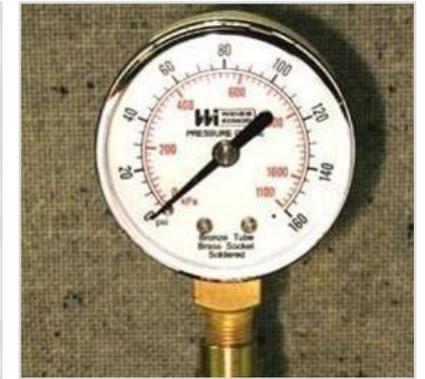
Degraded diaphragm assembly

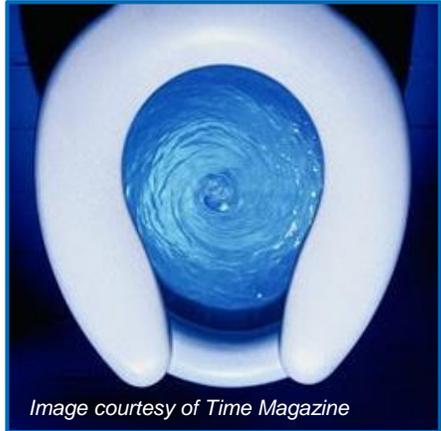
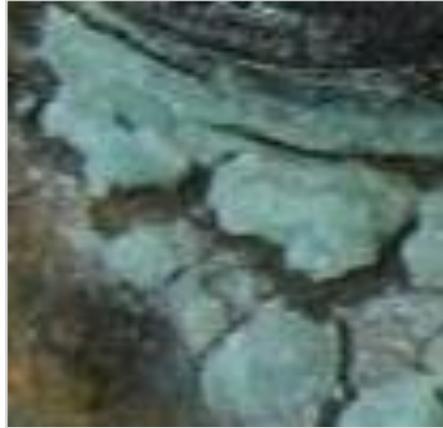
Debris blocking bypass

Symptom	Cause	Solution
Continuous flush with no shut-off	Debris blocking bypass	Clean or replace piston
	Debris under piston	Remove debris
	Degraded relief valve seat	Replace the piston assembly
	Low pressure drop	Check facility or municipal line pressure

In all cases, it's good to flush debris from the line

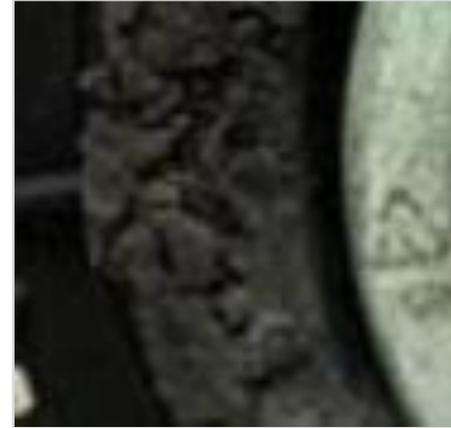
Debris under piston

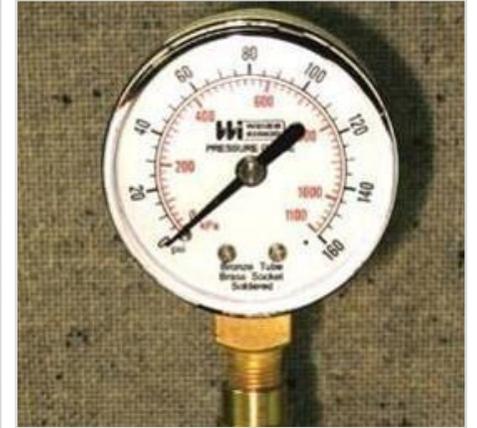
Degraded relief valve seat

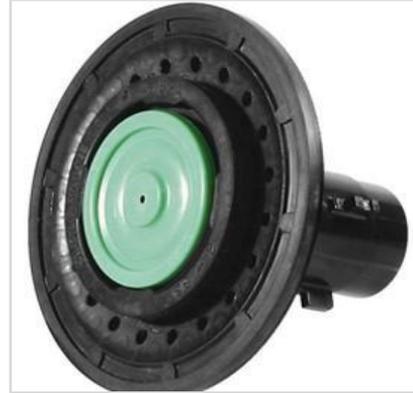
Low pressure

Symptom	Cause	Solution
No evacuation when flushed (either sensor or override button)	Low pressure (<25 psi / <1.7 bar)	Address plumbing system deficiencies
	Low consumption (LC) or urinal diaphragm installed in older closet	Install correct gpf diaphragm
	Short flushing (perforated diaphragm)	Replace diaphragm
	Cover not properly tightened (DFB - dual filter bypass diaphragm)	Tighten cover

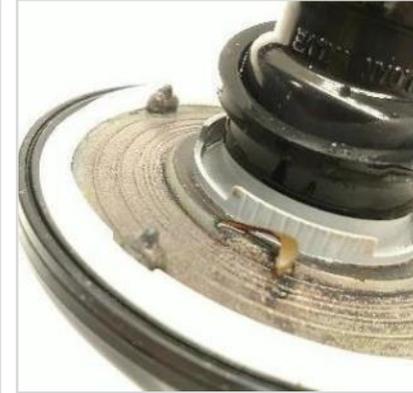
Improper, low consumption, or urinal diaphragm

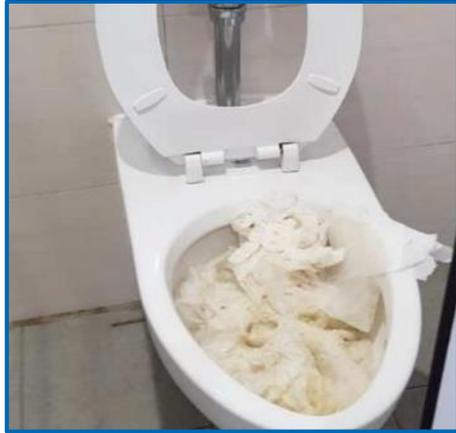
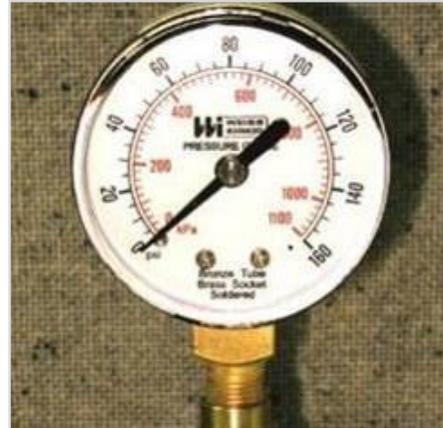
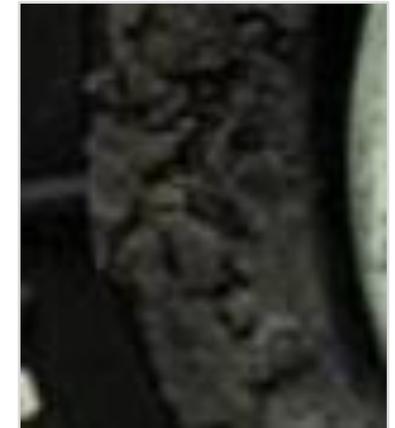
Low pressure

Incorrect piston

Piston lip seal degradation

Symptom	Cause	Solution
No evacuation when handle is depressed	Low pressure (<25 psi/<1.7 bar)	Adjust control stop to increase flow pressure Address plumbing system deficiencies
	Incorrect piston installed	Match piston gpf (Lpf) to fixture gpf (Lpf)
	Piston lip seal degraded	Replace piston assembly

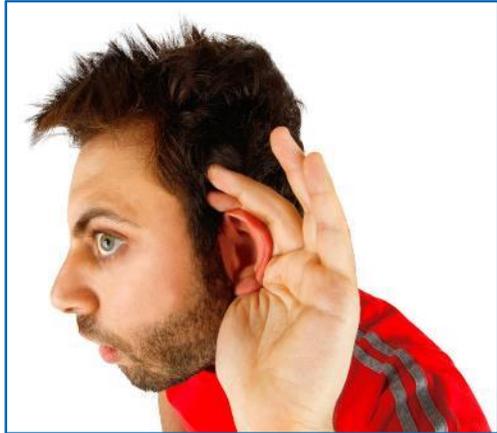
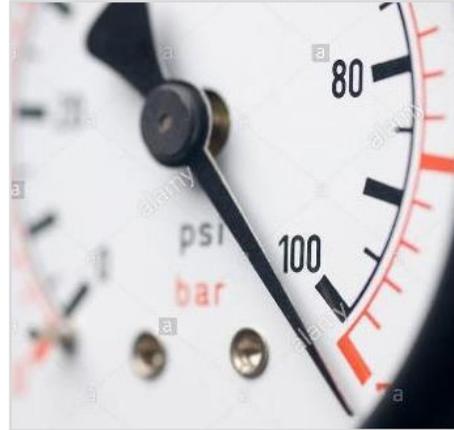
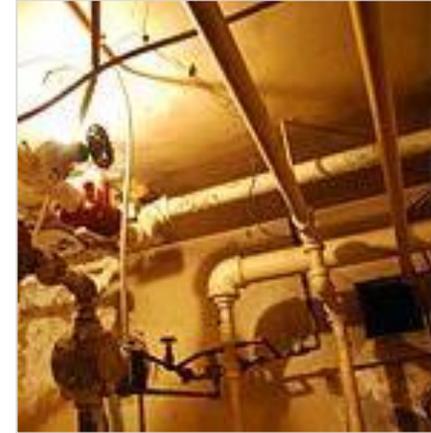
High flow pressure

Piston lip seal degradation

Loose plumbing

Symptom	Cause	Solution
"Thump" or "Bang" upon valve shut-off	High flow pressure	Adjust control stop to decrease flow pressure Decrease plumbing system flow pressure
	Piston lip seal degraded	Replace piston assembly
	Loose plumbing	Secure piping properly Check hammer arrestors

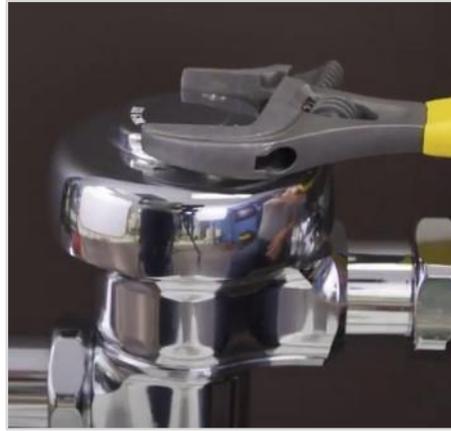
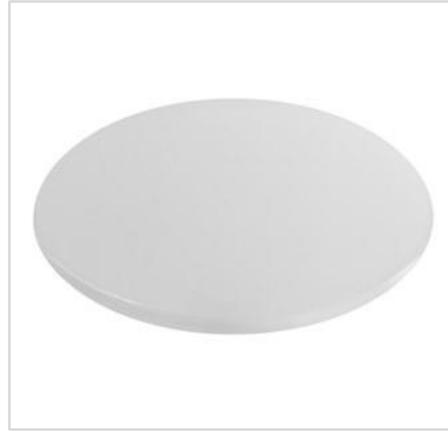
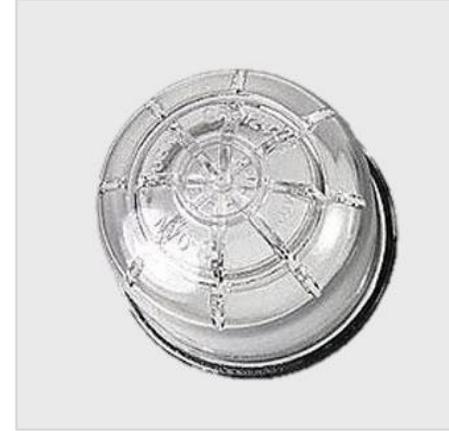
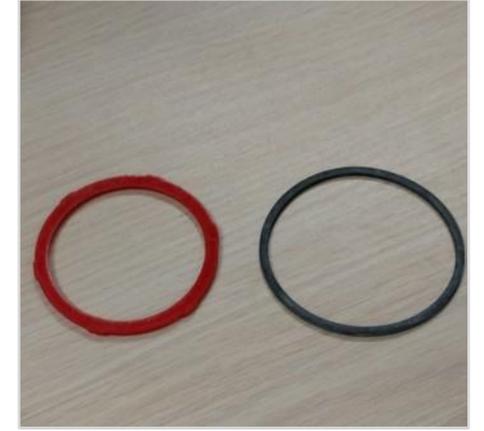
Always use a fixed smooth jaw wrench....

Cover not tight enough

Worn cover gasket (Gem)

Worn inside cover (Crown/Naval)

Worn cover gasket (Naval)

Symptom	Cause	Solution
Water leaking from threads beneath flushometer cover	Cover not tight enough	Turn off water and tighten cover
	Worn cover gasket (Gem)	Replace cover gasket (G106)
	Cracked inside cover (Crown)	Replace inside cover (CR124A)
	Worn cover gasket (Naval)	Replace cover gasket (CN76/CN105)

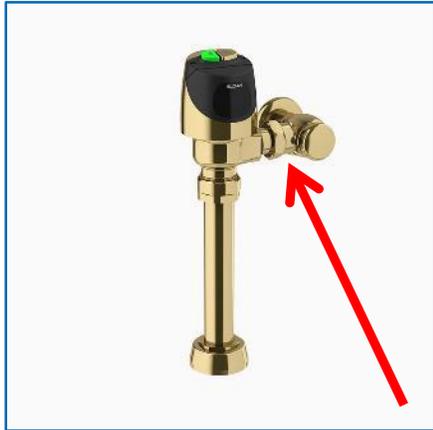
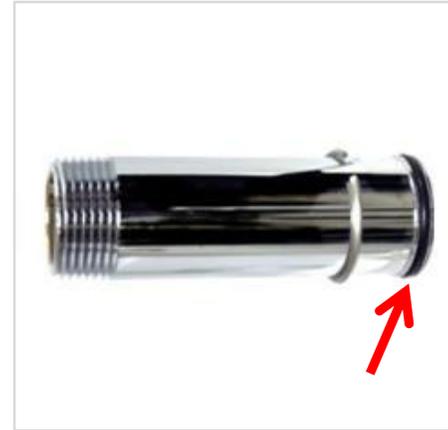
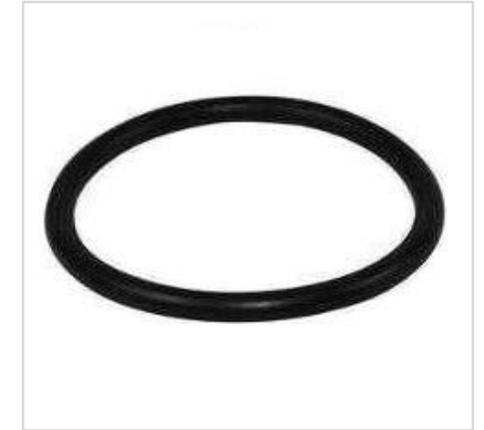
Tailpiece with O-ring

Sloan H553 O-ring

Symptom	Cause	Solution
Leaking at tailpiece next to control stop	Worn or degraded O-ring	Replace H553 O-ring

Clean the tailpiece O-ring groove and the control stop bore before replacing the O-ring. Use 100% silicone grease (not petroleum-based).

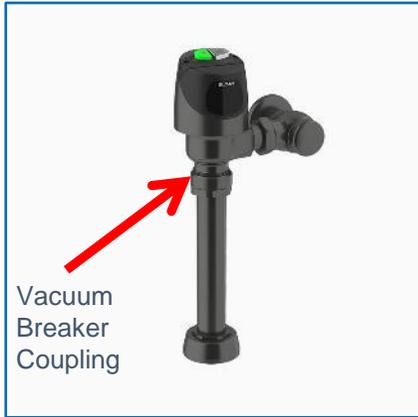
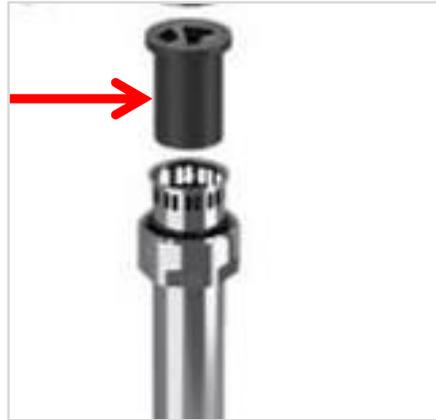
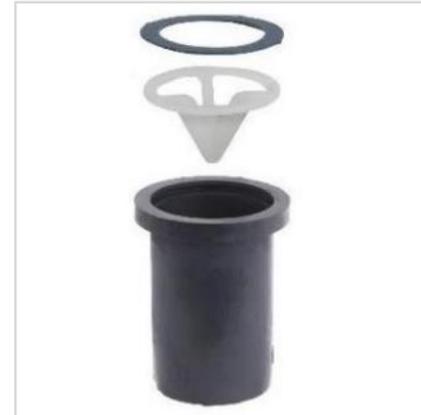
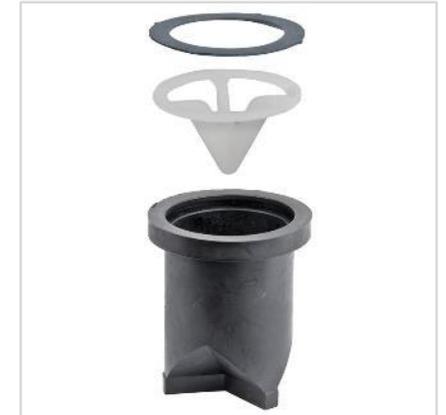
Worn vacuum breaker sack

Sloan V651A repair kit

Sloan V551A repair kit

Symptom	Cause	Solution
Dripping from <b>above</b> the vacuum breaker coupling during or after flush	Vacuum breaker sack damaged by over-tightening the vacuum breaker coupling	Clean vacuum breaker tube and replace vacuum breaker sack with V551A or V651A high backpressure VB repair kit
Dripping from <b>below</b> the vacuum breaker coupling during or after flush	Worn or degraded vacuum breaker sack

Wet the gasket prior to installation and hand tighten then “snug” with wrench

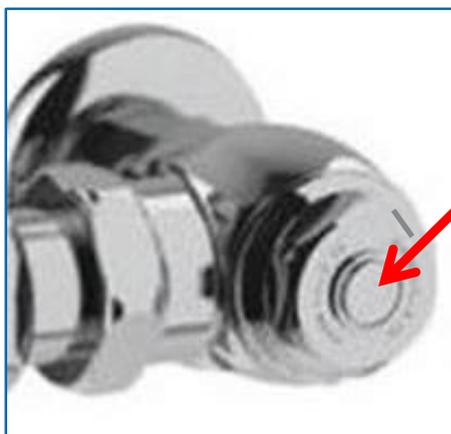
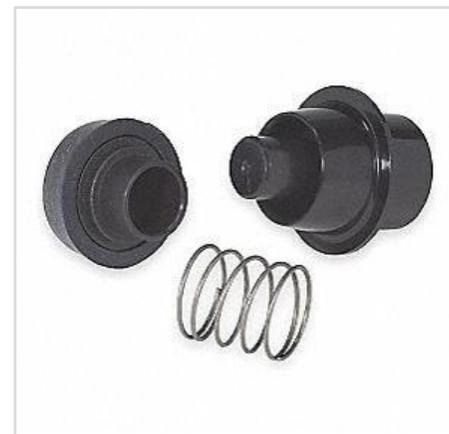
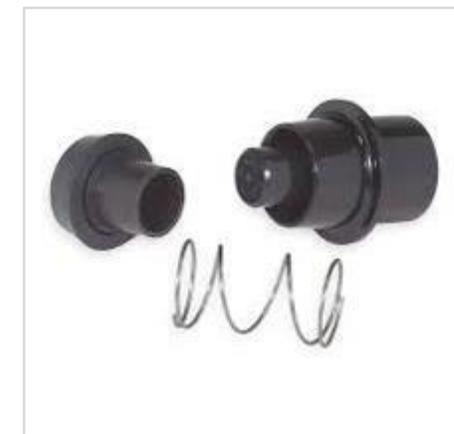
Control Stop Screw

Sloan H541ASD repair kit

Sloan H543ASD repair kit

Symptom	Cause	Solution
Leaking from control stop adjustment screw	O-ring inside the control stop is worn	Replace with H541ASD control stop repair kit (for older urinals, use H543ASD control stop repair kit)

If unsure of which urinal control stop kit you have for units manufactured between 1964 and 1994, contact Sloan Tech Service

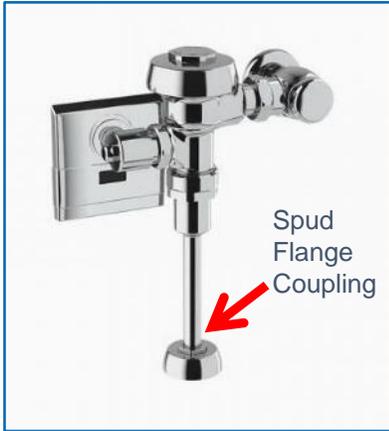
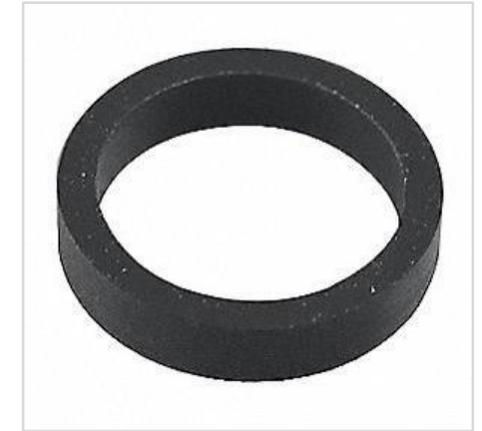
Sloan F3 friction ring

Sloan VBF5 gasket

Sloan F5 gasket

Symptom	Cause	Solution
Leaking from spud flange coupling	The spud flange coupling has loosened	Tighten spud flange coupling
	Spud flange coupling gaskets have become worn	Replace F3 friction ring and VBF5 gasket (1-1/4" or 1-1/2") or F5 gasket (3/4" or 1")

Clean the threads prior to installation, and never use pipe dope or grease!
