OLD Optima® ETF-500/ETF-500-S Faucets (Prior to 8-1-2018)

PARTS LIST—ETF-500 FAUCET

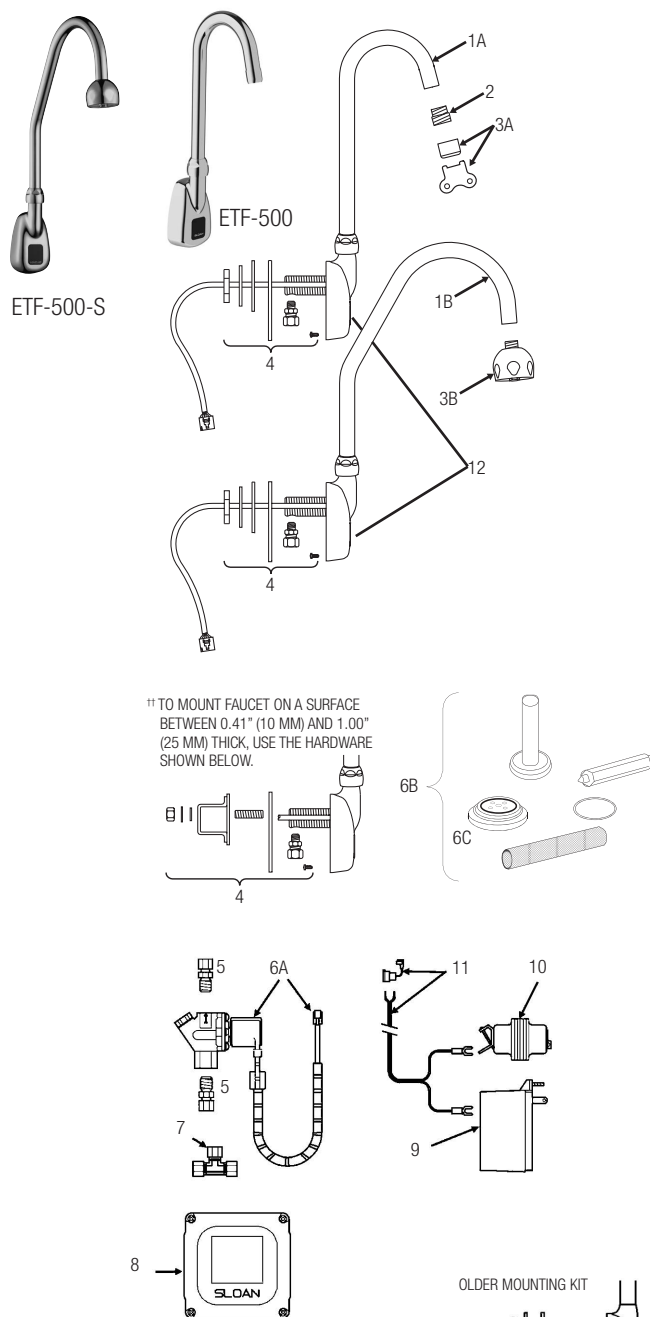
New Base Gasket

The new base gasket (in production since October 1999) is shown at right. An older base gasket design did not have the u-shaped drainage hole.

OLDER MOUNTING KIT
