## Gem-2® Flushometer

### PARTS LIST

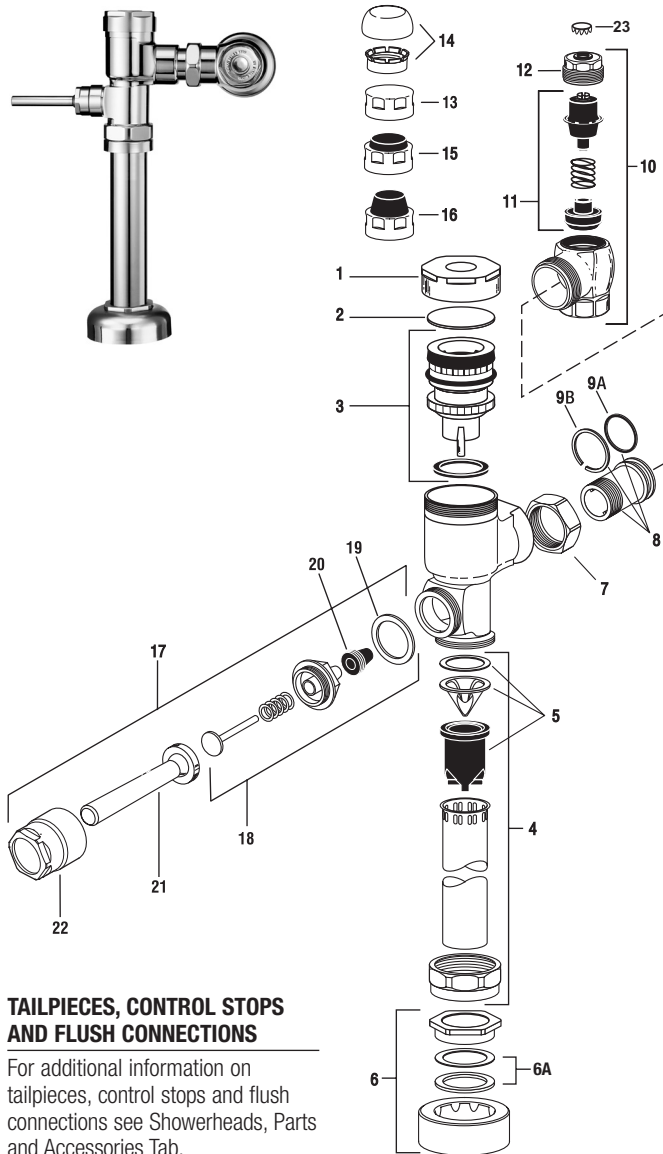
Item No.	Code No.	Part No.	Description
1.	<b>0307142PK</b>	G-105	CP Cover
2.	<b>0307139</b>	G-106	Slip Disc
3.	<b>3307135</b>	G-1022-A	Piston Kit – 1.28 gpf/4.8 Lpf Water Closet
	<b>0307193</b>	G-1007-A	Piston Kit – 3.5 gpf/13.2 Lpf Water Closet
	<b>0307195</b>	G-1016-A	Piston Kit – 1.6 gpf/6 Lpf Water Closet
	<b>0307192</b>	G-1009-A	Piston Kit – 1.5 gpf/5.7 Lpf Urinal
	<b>0307185</b>	G-1017-A	Piston Kit – 1.0 gpf/3.8 Lpf Urinal
	<b>3307133</b>	G-1018-A	Piston Kit – 0.5 gpf/1.9 Lpf Urinal
	<b>3307134</b>	G-1019-A	Piston Kit – 2.4 gpf/9.0 Lpf Water Closet
	<b>3307136</b>	G-1023-A	Piston Kit – 0.125 gpf/0.5 Lpf Urinal
	<b>3307137</b>	G-1024-A	Piston Kit – 0.25 gpf/1.0 Lpf Urinal

4.	<b>5323005</b>	V-500-AA	3/4" x 9" Vacuum Breaker – 6 per package
	<b>5323006</b>	V-500-AA	1-1/4" x 9" Vacuum Breaker – 6 per package
	<b>5323007</b>	V-500-AA	1-1/2" x 9" Vacuum Breaker – 6 per package

5.	<b>3323192</b>	V-551-A	Vacuum Breaker Repair Kit
6.	<b>3332002</b>	CR-1010-A	1-1/2" (38 mm) Spud Coupling
	<b>3332001</b>	CR-1009-A	1-1/4" (32 mm) Spud Coupling
	<b>3332000</b>	CR-1008-A	3/4" (19 mm) Spud Coupling
6A.	<b>SEE SLIP JOINT GASKETS AND RINGS TABLE BELOW LEFT</b>

7.	<b>0308676PK</b>	H-550	Stop Coupling
8.	<b>0308801</b>	H-551-A	Adjustable Tailpiece 2-1/16" (Standard Length)
9A.	<b>5308696</b>	H-553	O-ring – 24 per package
9B.	<b>5308381</b>	H-552	Locking ring – 12 per package

10.	<b>3308876</b>	H-790-A	1" Screwdriver Bak-Chek® Stop CP – complete
	<b>3308875</b>	H-790-A	3/4" Screwdriver Bak-Chek® Stop CP – complete
11.	<b>3308853</b>	H-541-A	Control Stop Repair Kit*
	<b>3308856</b>	H-543-A	Control Stop Repair Kit**

12.	<b>0308612PK</b>	H-622	CP Bonnet*
	<b>0308843</b>	H-577	CP Bonnet** – DISCONTINUED
13.	<b>3308840</b>	H-573-A	Control Stop Cap**
14.	<b>3388017</b>	H-1017	Flow Control (HEU Only) (Not Shown)

15.	<b>3308866</b>	H-574	Control Stop w/Bumper (-YO Variation)*
16.	<b>3308867</b>	H-576	Control Stop w/Extended Bumper (-YG Variation)*

17.	<b>0307100</b>	G-143	Handle Assembly
18.	<b>5307074</b>	G-50-A	Handle Repair Kit – 6 per package
19.	<b>5307065</b>	G-35	Handle Gasket – 48 per package
20.	<b>5302297</b>	B-39	Handle Seal – 12 per package
21.	<b>0307024PK</b>	G-145	Handle Grip
22.	<b>0307020PK</b>	G-144	Handle Socket
23.	<b>5388002</b>	H-528	Control Stop Plug Kit CP* (12 per pack)

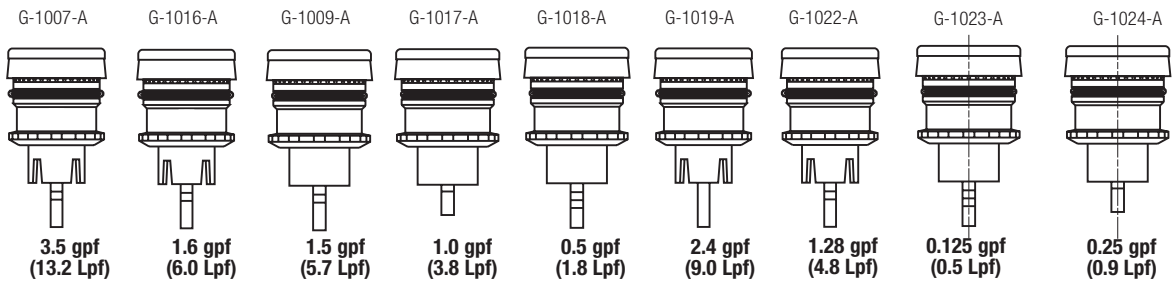
Gem-2 Pistons can be identified by the color, shape and marking of the above components.

Code No.	Part No.	Description	Cover Color	Piston Color	Barrel	Grooves
<b>0307193</b>	G-1007-A	3.5 gpf (13.2 Lpf) – Water Closet	White	Gray	Slotted	2
<b>0307195</b>	G-1016-A	1.6 gpf (6.0 Lpf) – Water Closet	Green	Green*	Slotted	2
<b>0307192</b>	G-1009-A	1.5 gpf (5.7 Lpf) – Urinal	Black	Black	Solid	2
<b>0307185</b>	G-1017-A	1.0 gpf (3.8 Lpf) – Urinal	Yellow	Black	Solid	1
<b>3307133</b>	G-1018-A	0.5 gpf (1.8 Lpf) – Urinal	Red	Black	Solid	3
<b>3307134</b>	G-1019-A	2.4 gpf (9.0 Lpf) – Water Closet	Blue	Gray	Slotted	0
<b>3307135</b>	G-1022-A	1.28 gpf (4.8 Lpf) – Water Closet	Deep Purple	Tan*	Slotted	2
<b>3307136</b>	G-1023-A	0.125 gpf (0.5 Lpf) – Urinal	Pink	Burgundy	Solid	3
<b>3307137</b>	G-1024-A	0.25 gpf (0.9 Lpf) – Urinal	Burgundy	Burgundy	Solid	1

\*Prior to February 2020 piston body color was black

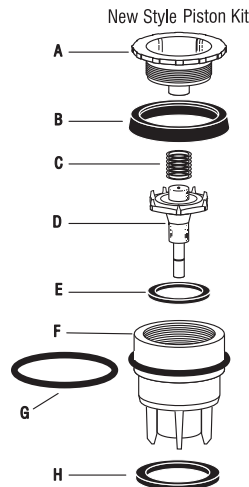
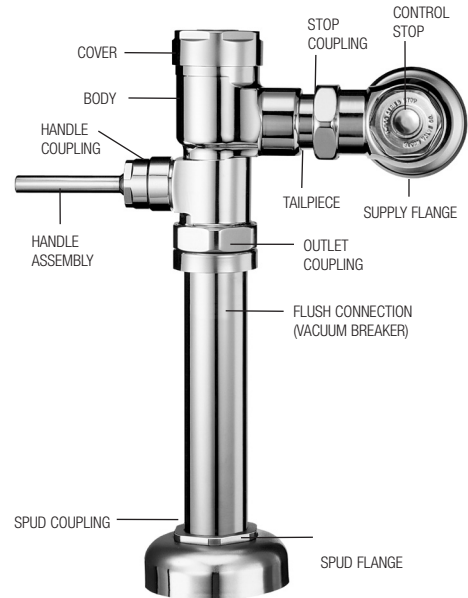
### ITEM 3. PISTON COMPONENTS

Item	Code No.	Part No.	Description
A.	***	***	Piston Cover
B.	<b>5307106</b>	G-78	Molded Cup – 12 per package
C.	<b>0307130</b>	G-102	Spring
D.	***	***	Relief Valve
E.	<b>0307116</b>	G-95	Relief Valve Seat
F.	***	***	Piston Body
G.	<b>0307210</b>	G-85	Filter O-ring
H.	<b>5307052</b>	G-21	Main Seat – 6 per package

Code No.	Part No.	Description
<b>3307128</b>	G-1011-A	Repair Kit includes Items: 2, B, C, E, G & H

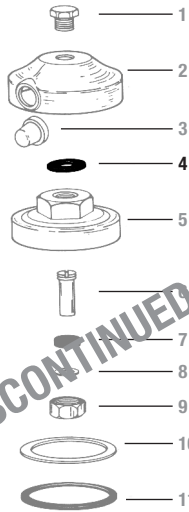
### REPAIR PARTS FOR OLD STYLE GEM FLUSHOMETERS (PRE-1985) Adjustable Cover

Item			
No.	Code No.	Part No.	Description
1.	—	G-24	CP Cover Screw – <b>DISCONTINUED</b>
2.	—	G-23	CP Cover – <b>DISCONTINUED</b>
	—	G-26	CP Cover for Bumper – <b>DISCONTINUED</b>
3.	—	G-27	Bumper (12 per package) – <b>DISCONTINUED</b>
4.	<b>0307058</b>	G-25	Cover Gasket (12 per package)
5.	—	G-4	RB Inside Cover – <b>DISCONTINUED</b>
6.	—	G-6	RB Regular Screw – <b>DISCONTINUED</b>
7.	—	S-26	Packing <b>DISCONTINUED</b>
8.	—	S-24	Packing Disc <b>DISCONTINUED</b>
9.	—	G-10	RB Packing Nut – <b>DISCONTINUED</b>
10.	—	G-65	Gasket – <b>DISCONTINUED</b>
11.	—	G-5	Gasket <b>DISCONTINUED</b>
